Auto Investigation #1

ENGINEERING REPORT

June 2006

PREPARED FOR: AUTO INSURANCE COMPANY #1

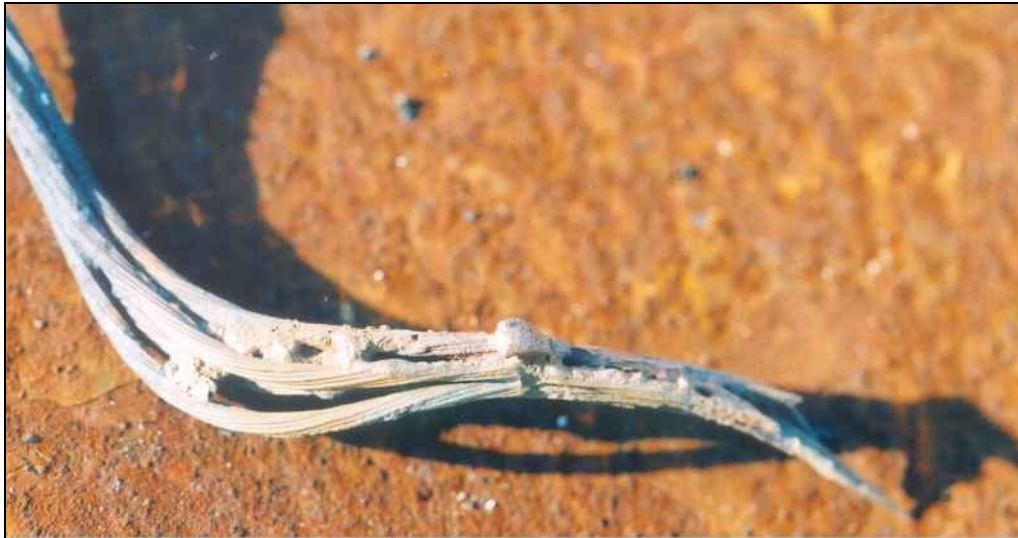
Figure 1 - Arc Faulting of Conductor Harness

The author removed the harness from the vehicle to facilitate detailed examination of the same (*Photographs 18 and 19*). The harness was connected to another set of bare, stranded conductors as shown in *Photograph 20*. Further examination of the opposite end of the bare, stranded conductors revealed electrical conductor-to-conductor faulting as shown in *Photograph 21* and detailed in *Photograph 22*.

The author created **Figure 1** from *Photograph 22* to detail the arc faulting.

From the author's inspection of the subject vehicle, a substantial conductor-to-conductor arcing fault was discovered on a conductor harness discovered behind the driver's seat at the rear floorboard (reference **Figure 1** and **Figure 2**). It is believed that the subject conductors were energized at the time of the faulting. There were no other conductors in the passenger's compartment or engine compartment that showed indications of arc faulting.

It is believed with a reasonable degree of engineering certainty that the ignition source for the fire was the heat generated by inadvertent conductor-to-conductor faulting of the subject chassis harness. It is believed that the first fuel to the fire was the electrical insulation surrounding the same. As the author was not able to access the complete maintenance history of the vehicle, assignment of responsibility to the vehicle manufacturer or subsequent repair entity could not be made.

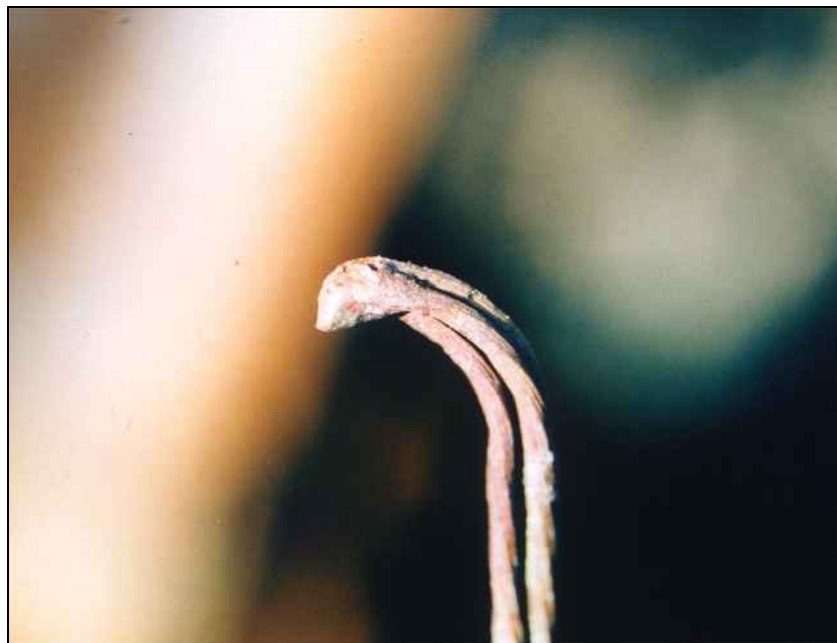
Figure 2 - Arc Faulting of Conductor Harness Continuation Run

The author discovered the other half of the arc faulted conductor harness on the rear floorboard as shown in *Photograph 23*. The author created **Figure 2** from *Photograph 24* to detail the arc fault and melted termination of the harness continuation run.

Photograph 25 details the view of the arc fault opposite the view in *Photograph 24*.

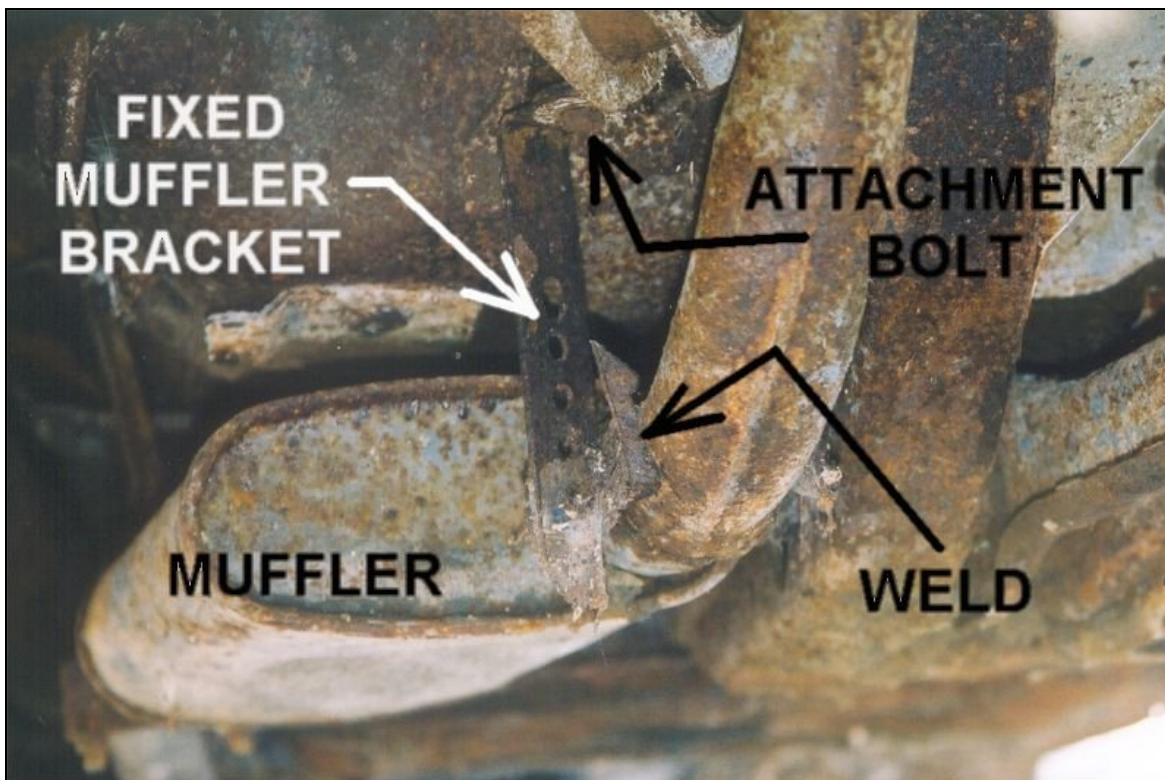
Figure 3 - Undamaged Fixed Passenger's Side Muffler Bracket

The passenger's side and driver's side muffler hangars appeared as shown in the aft-looking-forward view of the mufflers in *Photograph 29*. The passenger's side mount was a conventional rubber doughnut vibration isolation mount as shown in *Photograph 30*. The rubber isolator was consumed in the fire. The passenger's side of the vehicle was equipped with a straight bracket mount connected to the vehicle frame (*Photograph 31* and *Figure 3*).

As shown in *Figure 3*, the straight bracket was undamaged, contrary to the claimant's allegation that the bracket bent during the alleged bottom side impact and held the muffler abnormally close to the floor pan.

As shown in *Figure 3*, an approximate 1 inch air gap existed between the nearest approach between the muffler and the chassis floor pan. The bracket-to-pipe weld and frame attachment points were intact as shown, and the muffler appeared to be in a nominal, manufactured position.

The driver's side muffler mount was a conventional hooked bracket mount (reference *Photograph 30*) upon a rubber sound isolator. The passenger's side muffler mount was a straight bracket connected between the tailpipe and the chassis (reference *Figure 3*).

By examination of the straight bracket in *Figure 3*, the bracket was not bent as discussed in the insureds allegations and consequently, the muffler was held away from the underside of the chassis floor pan by at least 1 inch at closest approach.

It is therefore believed with a reasonable degree of thermodynamic certainty that the opined ignition source (i.e., exhaust system contact with the underside of the vehicle) has no credible basis in thermodynamics and therefore, per the requirements of NFPA 921, be discarded.
