Auto Investigation #2

ENGINEERING REPORT

INSURED: MR. WILLIE BROWN

DATE OF LOSS: JANUARY 2004

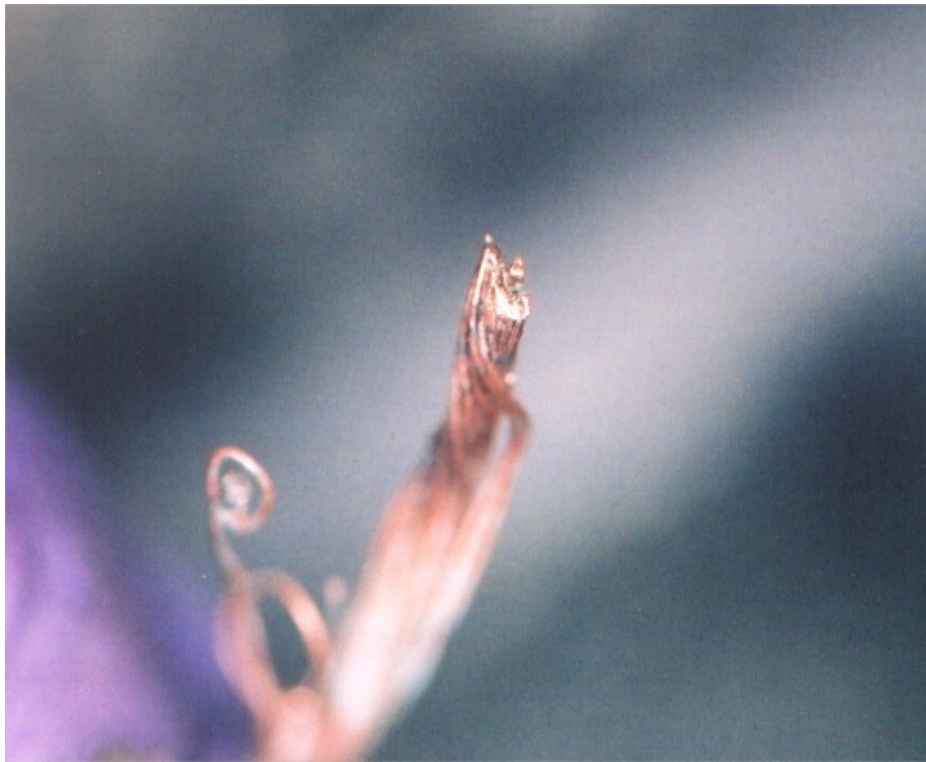
Figure 1 - Melted End of Engine Compartment Harness Conductor

One of the stranded conductors that was situated within an engine compartment harness (reference *Photograph 16*) showed evidence of arcing and was severed by melting. **Figure 1**, which was developed from *Photograph 24*, shows the melted end of the conductor. The opposite side view of the conductor end is shown in *Photograph 25*.

Two conductors were discovered severed by melting: 1) a stranded conductor that was attached to the engine management computer (reference *Photographs 22 and 23*) and 2) a stranded conductor that was attached to one of the engine compartment-mounted conductor harnesses (reference *Figure 1*). In addition, one conductor situated in the conductor harness that spanned between the passenger compartment and engine compartment was discovered with arcing and metal transfer from another conductor (reference *Figure 2*).

By examination of the length of the subject conductors and placement of the conductors in proximity to the probable mounted location of the fuse and relay panel and the engine management computer, it is believed that the subject shorted and arced conductors were situated in the suspected fire origin region at the time of the fire.

It is believed that the electrical insulation on the subject conductors failed by chaffing with each other and/or adjacent (grounded) chassis structure. As a result of the failure of the electrical insulation, it is believed that the conductors came into intermittent contact with each other.

It is believed that the ignition source for the fire was heat generated by inadvertent current flow during the electrical arcing. It is believed that the first fuel to the fire was the electrical insulation surrounding the conductors. It is believed that Vehicle Company #1, acting as the design and manufacturing agent for the subject vehicle, did not adequately provide chafe protection for the subject conductors. It is believed that Vehicle Company #1 is responsible for the conditions that led to the subject fire loss.

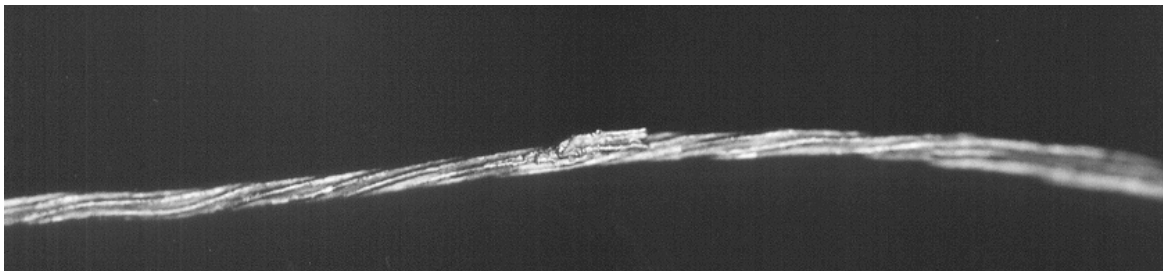
Figure 2 - Passenger's Compartment Harness Conductor That Was Damaged by Arcing

The conductor harnesses that spanned between the passenger's compartment and engine compartment were laid out for inspection as shown in *Photograph 26*. Close inspection of the conductors (*Photograph 27*) showed one conductor that had experienced arcing and copper transfer from another conductor. The arcing appeared as shown in *Figure 2*, which was developed from *Photograph 28*.
