Auto Investigation #3

ENGINEERING REPORT

INSURED: DAVE'S AUTO SERVICE

DATE OF LOSS: NOVEMBER 2001

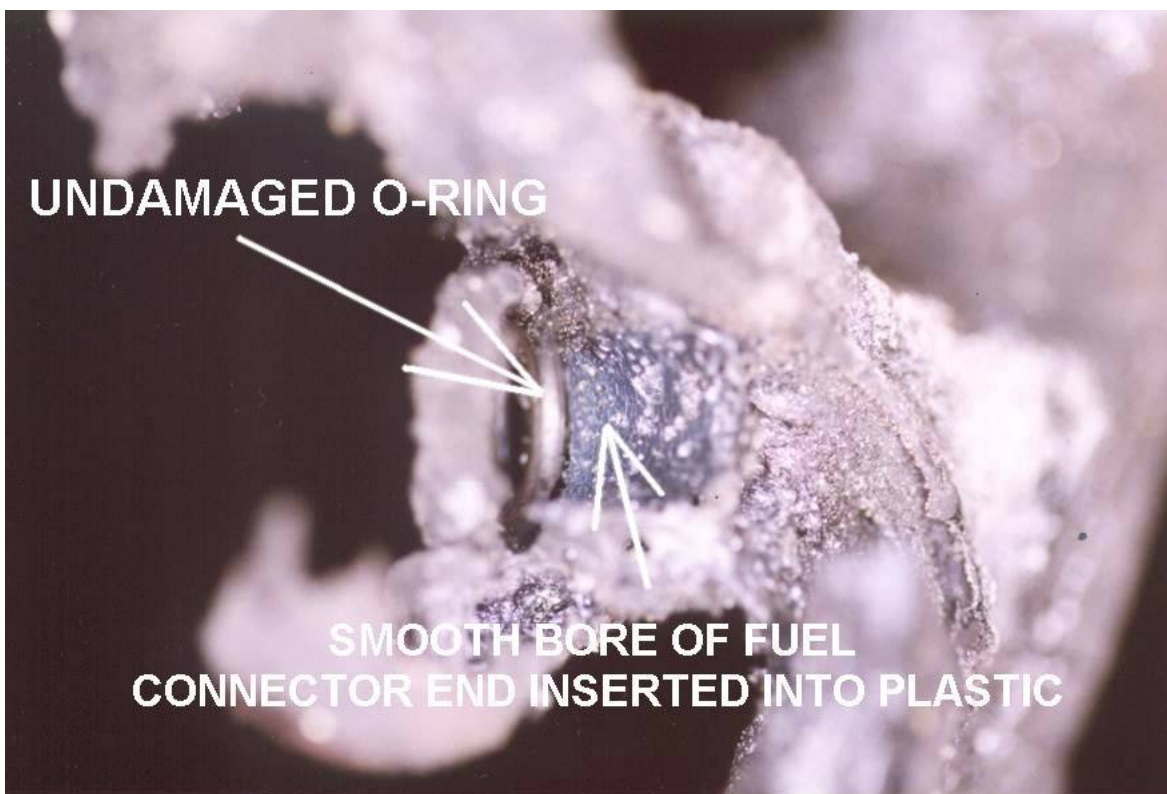
Figure 1 - FUEL RAIL REMNANT SHOWING O-RING AND FUEL HOSE END IMPRESSION

Figure 1, which was derived from *Photograph 26*, shows two evidence items pertaining to the insertion of the fuel hose connector end into the plastic fuel rail. The first item pertains to the nearly undamaged condition of the fuel sealing o-ring in the fuel rail. The o-ring, which is composed of low melting point rubber, was discovered nearly undamaged as shown in *Figure 1*.

Had the fuel hose separated from the fuel rail at the connector *prior* to the fire, the fire would have charred or consumed the o-ring. Instead, the o-ring was protected from the fire by the wide flange of the (inserted) fuel connector. Reference *Photographs 22, 23, and 24* for flange configuration that mates with the o-ring.

The second item shown in **Figure 1** is the conspicuous smooth impression in the plastic fuel rail of the steel fuel hose end fitting. The plastic fuel rail had melted *around* the fuel fitting. Had the fuel hose connector not been in place before the fire, the impression of the steel fuel hose end would not have been evident.

It is therefore believed that the fuel hose connector end was fully inserted into the fuel rail (i.e., against the subject o-ring) prior to and during the subject fire. It is also believed that an unknown party(s) removed the subject fuel hose from the fuel rail remnant prior to the author's inspection. The fuel hose was discovered continuous and undamaged back to the fuel tank.

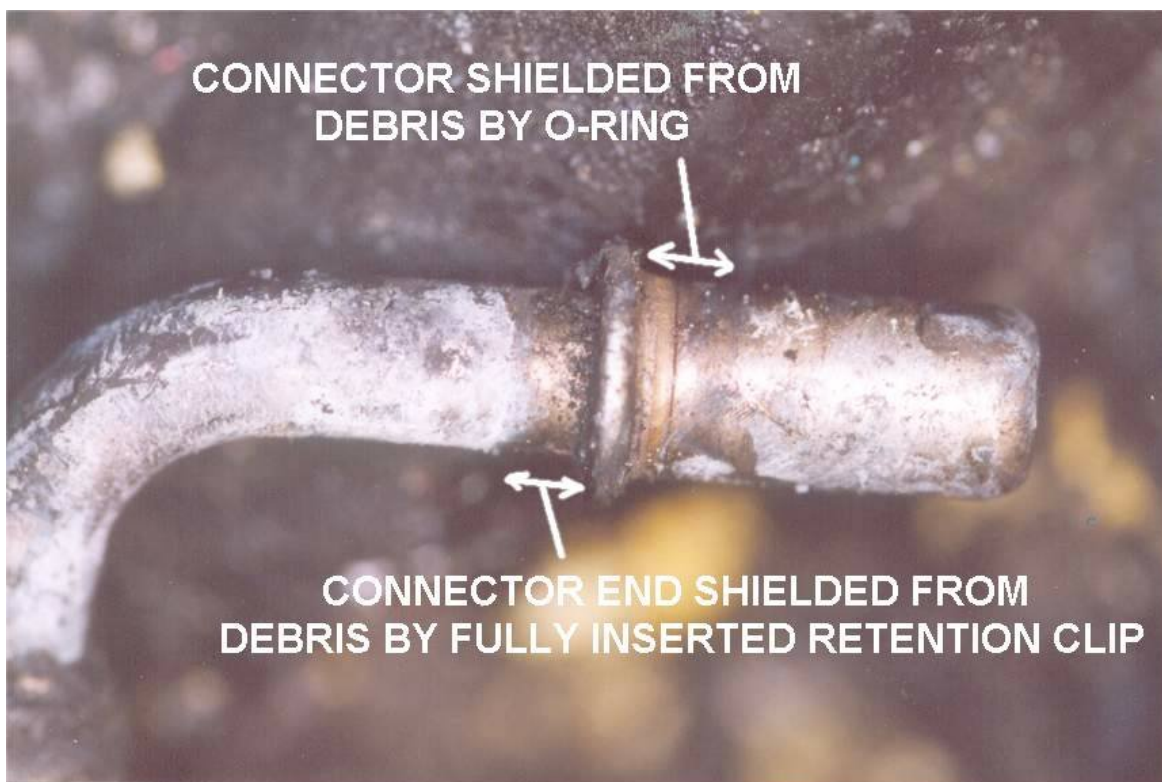
Figure 2 - FUEL HOSE END DEBRIS PATTERNS

Figure 2 (below), developed from *Photograph 23*, shows the top of the fuel connection positioned as installed relative to the fuel rail.

As can be seen in **Figure 2**, the top periphery of the fuel hose connector was shielded from fire extinguisher debris. The only protection afforded to the region would have been from a fully inserted fuel hose retention clip. The retention clip was properly seated against the

tube end (i.e., fully installed) to create the observed pattern. In addition, the tube end shows witness marks at the location of the fuel rail o-ring.

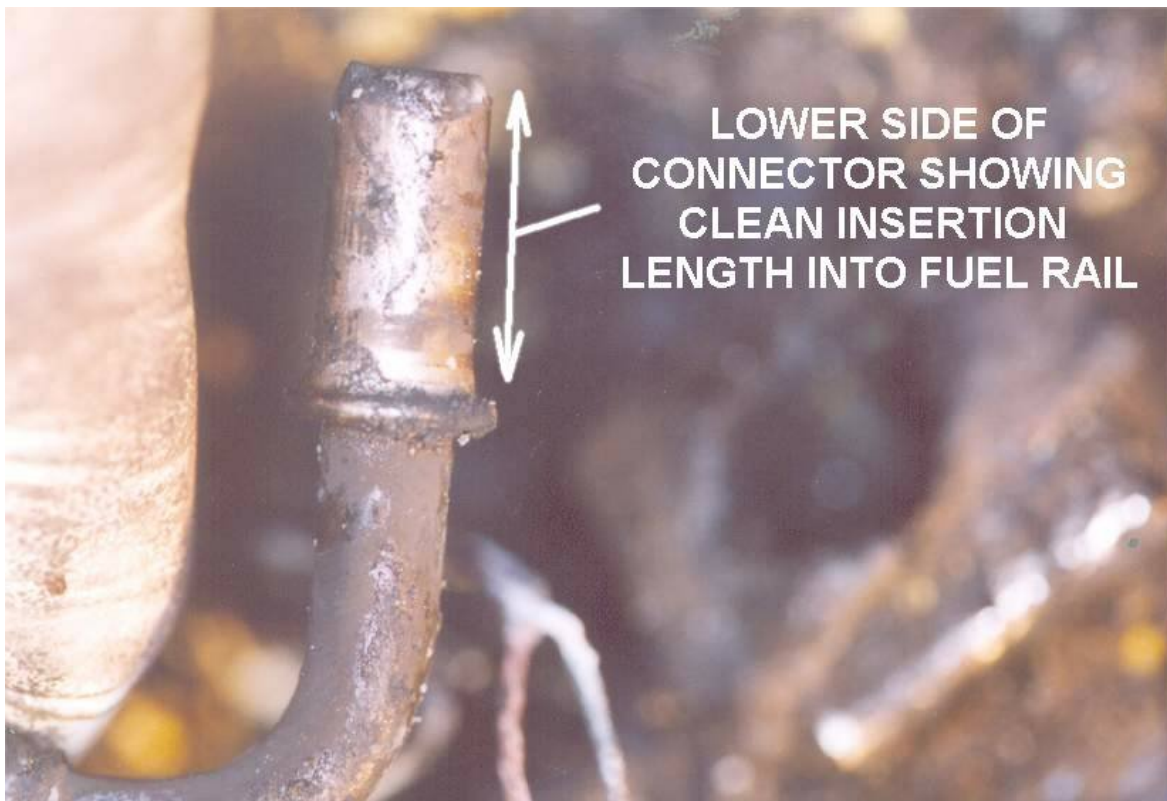
Figure 3 - LOWER (ENGINE SIDE) OF FUEL HOSE CONNECTOR

Figure 3 (below), developed from *Photograph 24*, shows the clean insertion length (i.e., into the fuel rail) that was directed toward the engine and not subject to fire extinguisher debris. Note: the fire penetrated the fuel rail and some of the fire extinguisher debris was discovered on the outward facing surface of the connector (reference **Figure 2**).

It should be noted in **Figure 3** that there were no markings from the retention clip because the retention clip did not pass around the lower periphery (i.e., the engine facing side) of the connector.

It is therefore believed that the subject fuel hose retention clip (reference Photographs 20 and 21) was properly installed and fully seated against fuel hose steel connector prior to and during the fire.

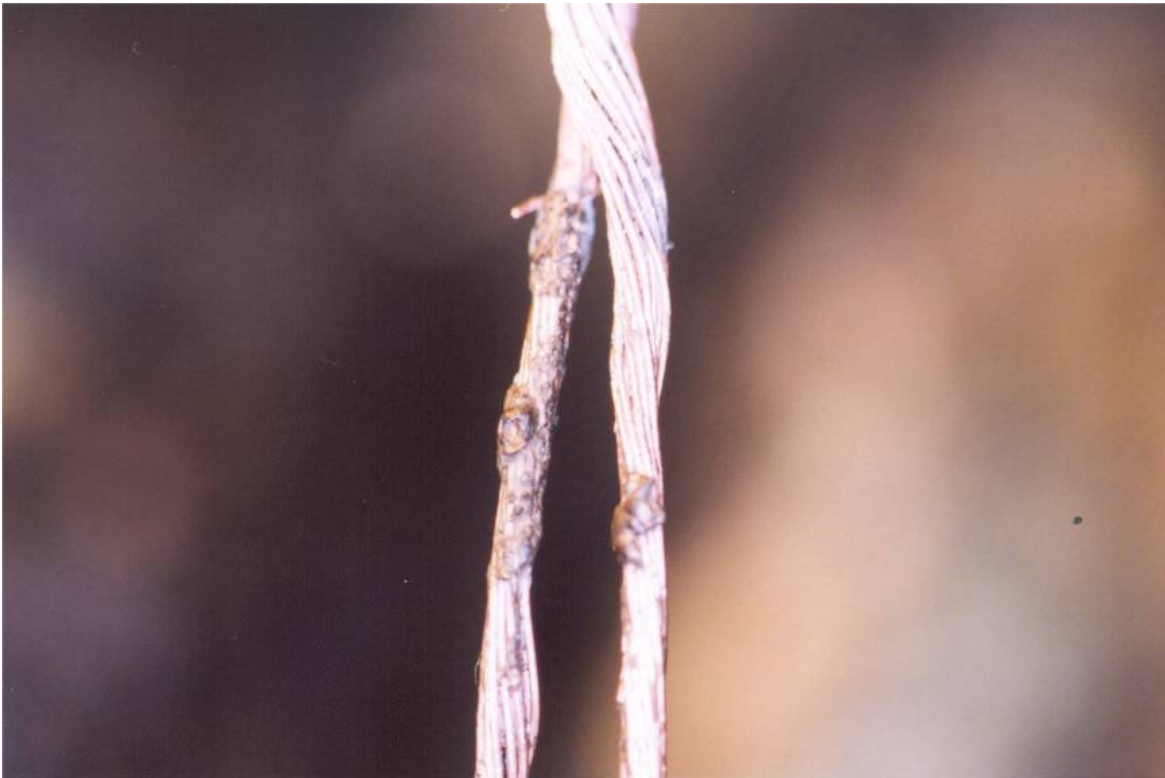
Figure 4 - THROTTLE POSITION SENSOR STRANDED CONDUCTOR FAULTS

The fuel injector electrical stranded wiring, the MAP sensor wiring, and the TPS stranded wiring were closely inspected using a 10x illuminated Coddington magnifier to detect arc faults along their lengths. Substantial arc marks and copper strand melting were discovered in two of the three stranded conductors from the TPS sensor in the vicinity of the plastic fuel rail.

Figure 4 (below), developed from *Photograph 15*, shows the arc and melting damage to the stranded small gage TPS conductors. It is believed by the author that the conductors operated at a 5 Volt DC potential, and direct conductor-to-conductor faulting caused the damage.

Evidence of a substantial electrical fault was discovered in two of three Throttle Position Sensor stranded copper conductors that were located upon and directly in contact with the driver's side fuel rail.

It is therefore believed that the ignition source for the fire was electrical arcing between the Throttle Position Sensor conductors. The first fuel to the fire was the electrical insulation surrounding the faulted conductors. Once the insulation around the conductors was ignited, it is believed that the fire quickly extended to the chafe guard around the conductors and to the adjacent driver's side plastic fuel rail. The report of a sudden, catastrophic fire resulting from the release of pressurized gasoline is consistent with witness reports.

It should be noted that no over-current protection devices operated during the event, and therefore the arcing was most probably sustained for a substantial period before and during the event. The conductors showed no knife or external injury marks that may have been caused by the October 2001 maintenance.
