Commercial Investigation #1

ENGINEERING REPORT

June 2006

INSURED: DEPARTMENT STORE #1
DATE OF LOSS: JUNE 2004
LOSS LOCATION: OHIO
POLICY NUMBER: N/A
CLAIM NUMBER: <omitted>
IC1 FILE NUMBER: <omitted>

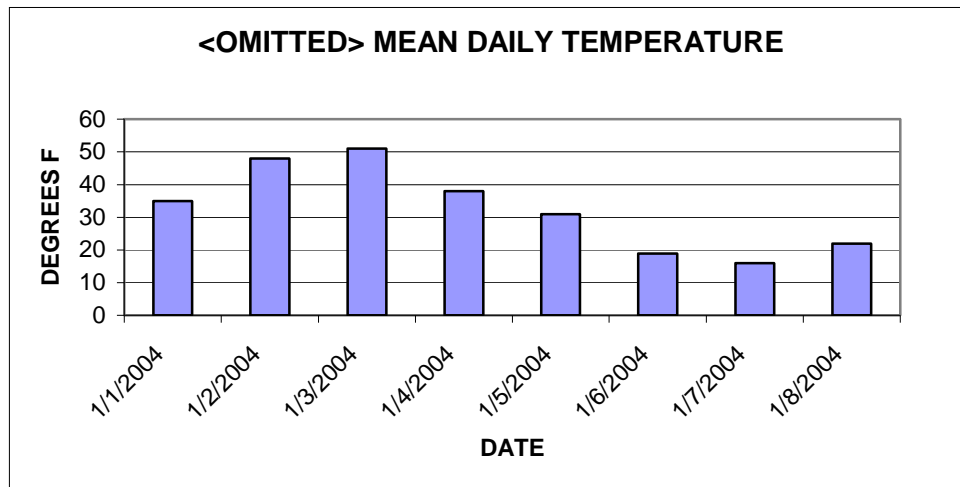
Figure 1 - Mean Daily Temperature for Week Prior to Event

As shown in *Figure 1*, the mean daily temperature remained at or below 19° F for the two days prior to the event. There was no other period where the mean daily temperature remained at or below 21° F for more than one day since system installation in August 2003.

Review of the regional temperature data for the region indicated that the mean daily temperature fell less than 19° F for the two days preceding the rupture event. At no other time since the reported installation of the system had the regional temperature stayed at or below 21° F for more than 1 day.

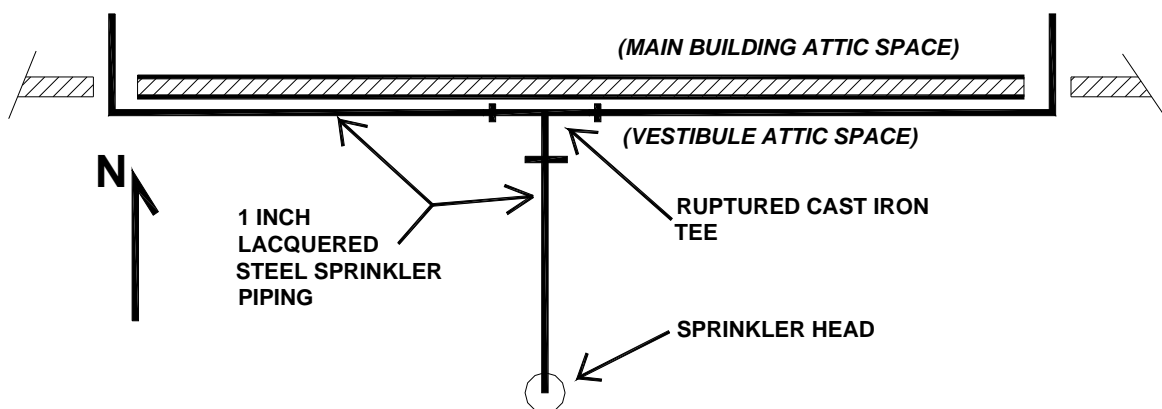
Figure 2 - Plan View of Vestibule Sprinkler Piping

The author created *Figure 1* to assist the reader in understanding the layout of the vestibule attic sprinkler piping. The right-hand span of sprinkler piping entered the heated main store attic space via the wallboard penetration shown in *Photograph 7*.

The subject tee was situated mid-span in two connector pipes that entered the heated attic space of the main building. In addition, the boss port of the tee connected to the sprinkler that extended down to the heated vestibule space. The tee, therefore, was situated at the most remote position relative to any other heated portion of the piping system.
