# Commercial Investigation #3

Re:            *Insured:*            Medical Facility #1  
                 *Loss Location:*       Columbus, Ohio  
                 *Claim No.:*            <omitted>  
                 *Date of Loss:*         August 2003  
                 *IC1 Project No.:*      <omitted>

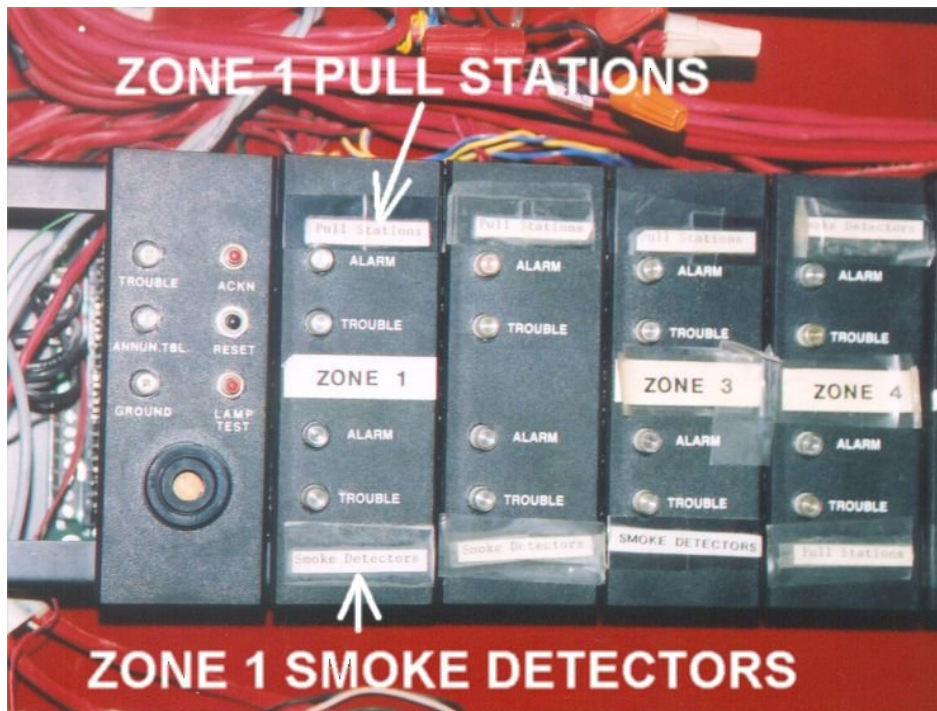
**Figure 1 - Zone Card Layout**

As shown in *Figure 1*, which was created from *Photograph 14*, the zone cards for Zones 1 through 4 were laid out with each card sharing alarm function for the smoke detectors

as well as the pull stations. Expansion alarm slots with blank cover plates were situated to the right of the Zone 1 through 4 cards (*Photograph 15*).

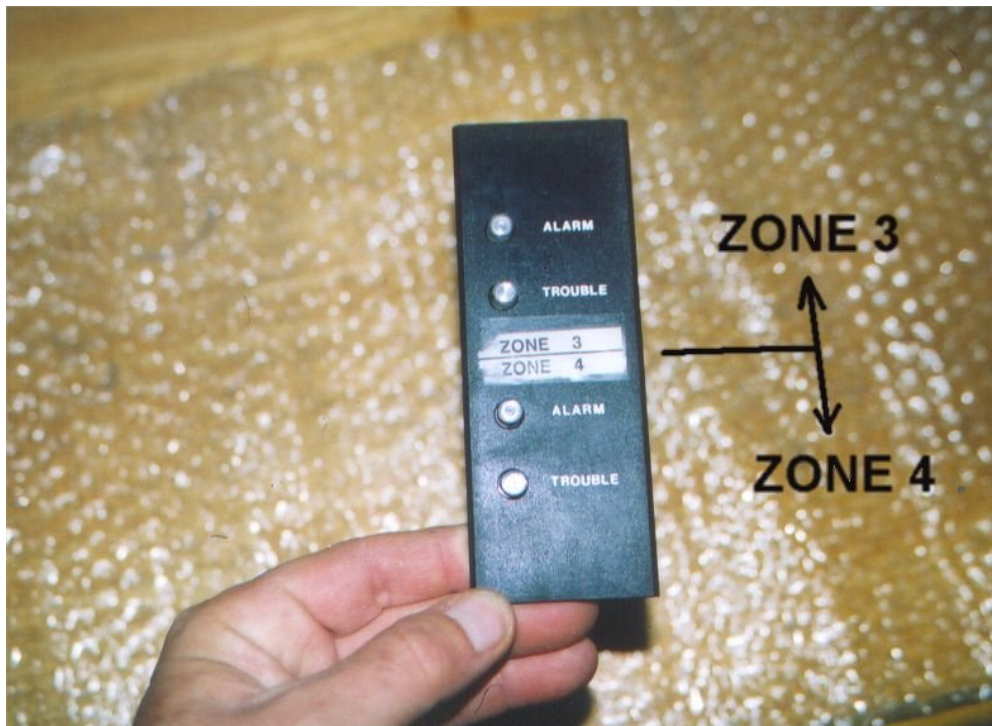
**Figure 2 - Zone Card Reportedly Removed from Alarm Panel Following August 27th Event**

*Figure 2*, which was developed from *Photograph 17*, shows a front view of the alarm card that was represented to have been taken from the subject alarm panel following the August 27<sup>th</sup> event.

As can be seen in *Figure 2*, the zone card was laid out in a completely different manner than the existing cards in the alarm panel (reference *Figure 1*). The zone card that was sent to the author *shared two different zones on the same card*, whereas the existing cards installed at the facility *shared pull stations and smoke detectors on the same card*.

*With regard to the zone card that was sent to the author by Mr. Davenport and represented to have been the zone card installed prior to the August 27<sup>th</sup> event, it is not believed the zone card was ever installed in the subject alarm panel. The zone card was marked in a manner that was completely inconsistent with the markings of the existing cards. The reportedly damaged zone card had indications of hand-soldering and a broken copper trace that was damaged by unknown means.*
