Heavy Equipment Investigation #1

ENGINEERING REPORT

June 2006

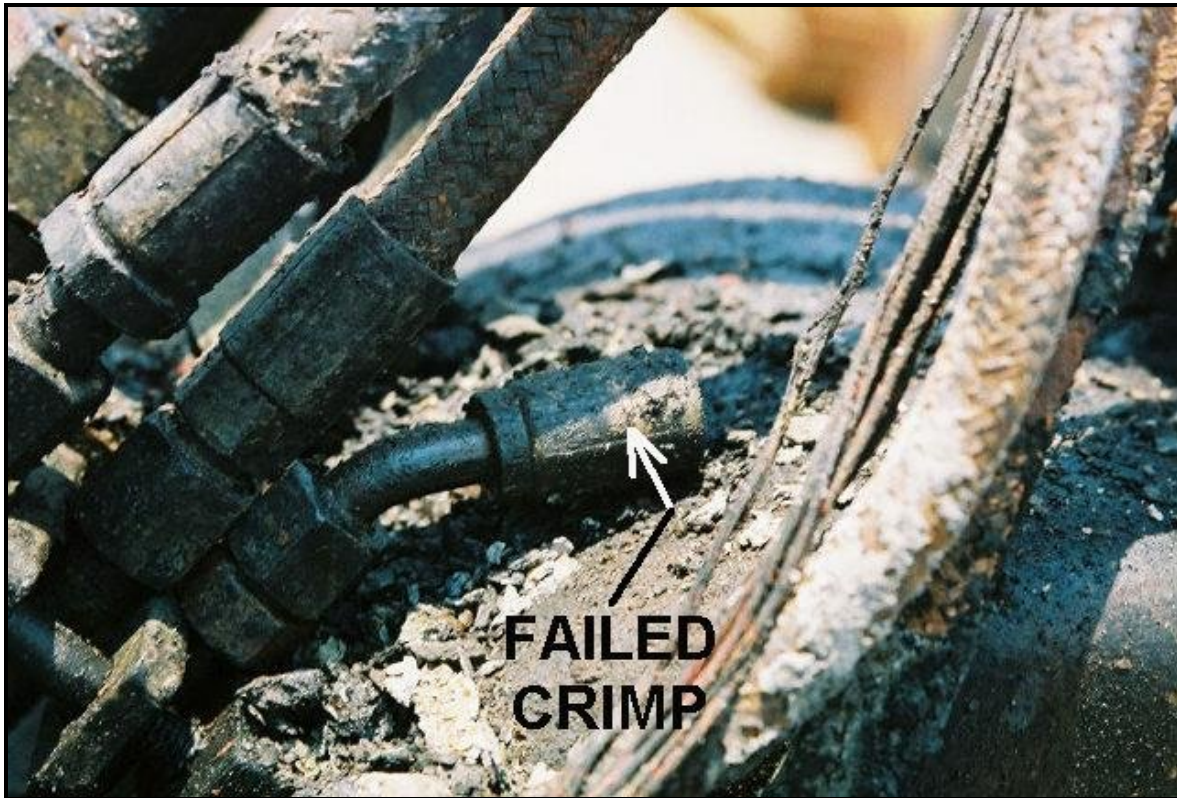
Figure 1 - Failed Hose Crimp Connection

Close inspection of the tube/hose interface (*Photograph 20*) revealed that the rubber tube supports had been completely consumed by the fire. In addition, one of the hoses (i.e., driver's side, lowest hose) had completely separated from the associated crimp joint.

The author created **Figure 1** from *Photograph 23* to assist the reader in understanding the layout of the failed crimp joint.

The author utilized a thin stylus to probe inside the crimp connection for remnants of hose or reinforcement material. There was no hose or reinforcement material present within the crimp connection. A charred hose end, which presumably was a portion of the noted hose, was positioned at the top of the articulation joint as shown in *Photograph 24*.

Comparison of the tube/hose interface (*Photograph 20* – affected unit and *Photograph 25* – exemplar) revealed that the connections at the interface did not share a common geometry. Specifically, with reference to *Figure 1*, the failed hose crimp joint was connected to a 45° adapter fitting, which in turn was connected to the backbone tube. Examination of the same tube/hose connection of the exemplar in *Photograph 25* revealed a straight adapter in place.

However, the author did discover a single hydraulic hose that had pulled from its respective crimp joint (reference **Figure 1**). As noted in the Observations section of this report, the geometry of the tube/hose interface did not follow the geometry of an exemplar Caterpillar 615C Scraper examined at Equipment Supplier #1.

It is believed with a reasonable degree of engineering certainty that the first fuel to the fire was hydrocarbon-based hydraulic fluid that was released to the environment when the noted hydraulic hose crimp connection suddenly and catastrophically failed during operation of the subject Heavy Vehicle. It is believed with a reasonable degree of engineering certainty that the ignition source for the fire was the exposed exhaust stack situated to the right of the operator's cab. Diesel exhaust stacks situated downstream of the turbocharger exhaust have a surface temperature in excess of 900° F, well above the auto ignition temperature of hydrocarbon-based oils.

promote catastrophic failure of a crimp joint include a poorly formed crimp of hose insert material and a routing from original assembly or defective maintenance that does not leave the hose in the lowest energy condition possible (e.g., sharp radii bends).

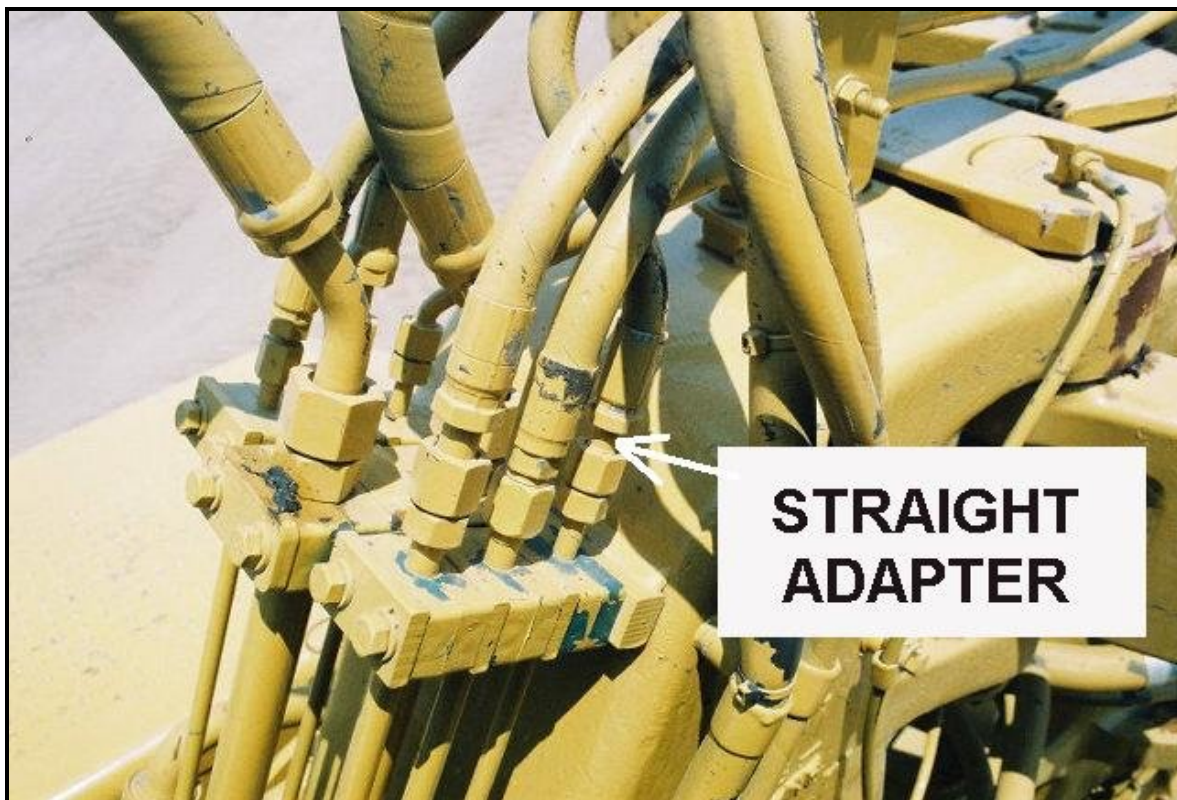
Figure 2 - Straight Adapter (Exemplar - Shown) Versus 45 Degree Adapter (Affected Unit)

The author created *Figure 2* to assist the reader in understanding the differences between the two units.

In an attempt to learn the proper geometry of the interface, the author consulted the *Caterpillar Disassembly and Assembly Manual* provided by Ms. Slovinof. The proper (i.e., design) geometry of the adapters used at the tube interface was shown for the passenger's side only in Illustration 249 (*Caterpillar Disassembly and Assembly Manual – p. 57*). The Manual showed no depictions of the affected, driver's side of the interface.
