Heavy Equipment Investigation #3

ENGINEERING REPORT

PREPARED FOR: TRANSPORT COMPANY #1
MISSISSIPPI

DATE OF LOSS: MARCH 2004

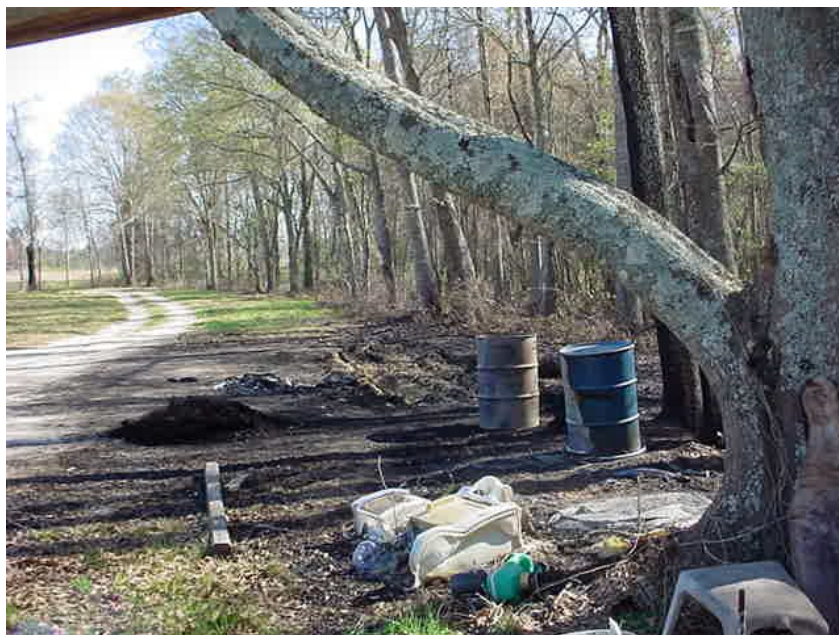
Figure 1 - View Looking Across Reported Loss Scene

Per the responding fire department report, County Fire-Rescue Incident Report (Appendix A), dated March 2004, Mr. Downing was reportedly burning waste in the open container as shown in the foreground in *Figure 1*. The “Possible Origin” of the subject fire was listed as “grass fire out of control”.

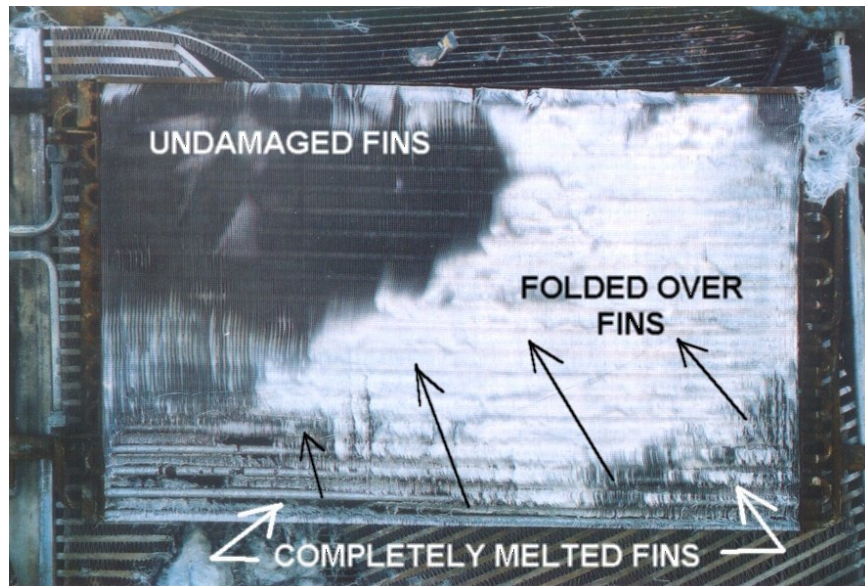
The aluminum-finned air conditioning condenser mounted at the front of the aluminum-cored turbocharger air intercooler experienced a large heat flux along its lower periphery and driver's side edge. *Figure 1*, which was created from *Photograph 25*, shows the effects of the directional heat flux emanating from below and to the driver's side of the condenser.

Figure 2 - Directional Heat Flux Directed Toward Air Conditioning Condenser
