Industrial Investigation #1

ENGINEERING REPORT

June 2006

INSURED: INDUSTRIAL PRINT COMPANY #1
DATE OF LOSS: MARCH 2004
LOSS LOCATION: PORTLAND, TENNESSEE
POLICY NUMBER: N/A
CLAIM NUMBER: <omitted>
IC1 FILE NUMBER: <omitted>

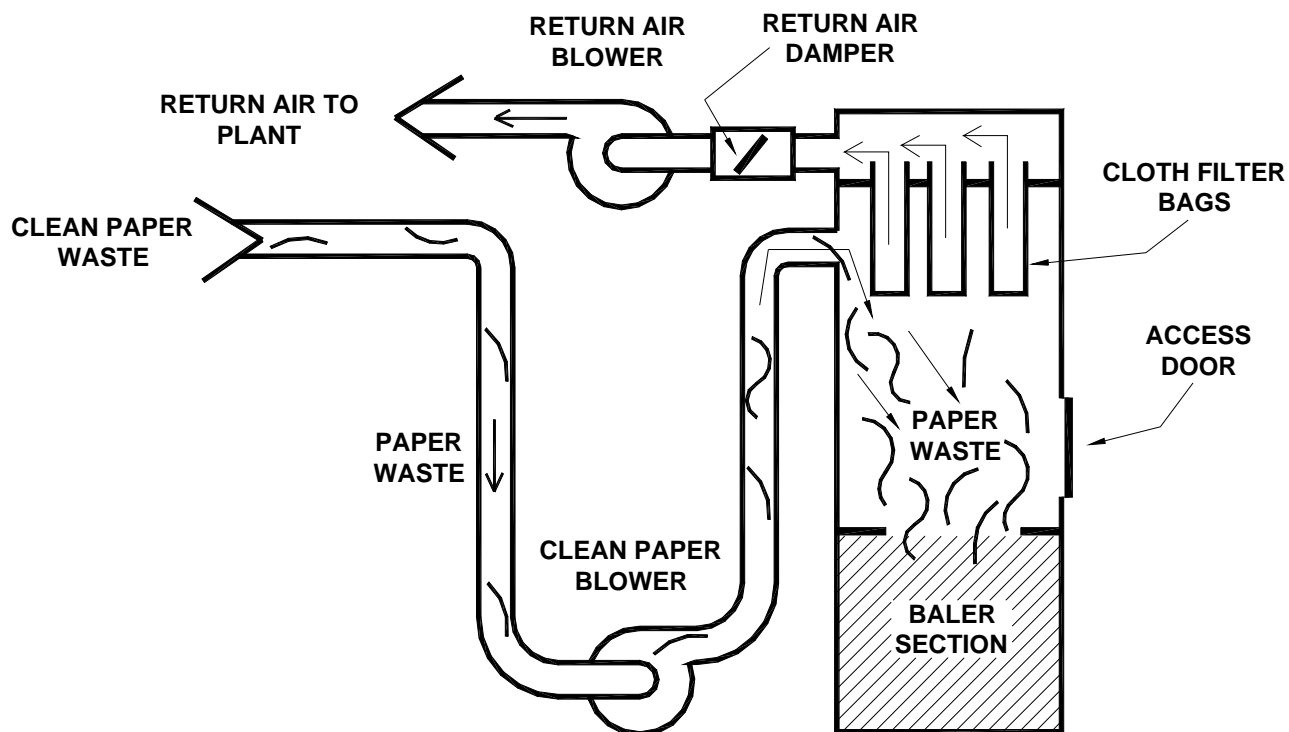
Figure 1 - Paper Waste Collection System Layout

The clean paper waste was pneumatically conveyed approximately 50 yards from binding machinery via a ducting system to the suction of a *clean paper centrifugal blower*. The blower transported the paper waste to a collection bin positioned above the *baling section*. Air was removed from the bin by a *return air centrifugal blower* that was positioned opposite a set of *cloth filter bags* at the top of the collection bin. A pressure balance across the filters was maintained by a set of moveable vanes in the *return air damper* that were controlled by a programmable logic controller (PLC).

At the time of the event, Mr. Roberts was reportedly walking at or near the access door positioned on the side of the collection chamber as shown in *Figure 1*, which was designated as “Baler A”. Two other collection/baler systems, designated “Baler B” and “Baler C”, were positioned sequentially to the west of Baler A. Baler B served to collect contaminated waste paper (i.e., paper trimmings that contained glue), and Baler C served to collect floor waste along with wastes from Balers A and B in case either system was taken out-of-service.

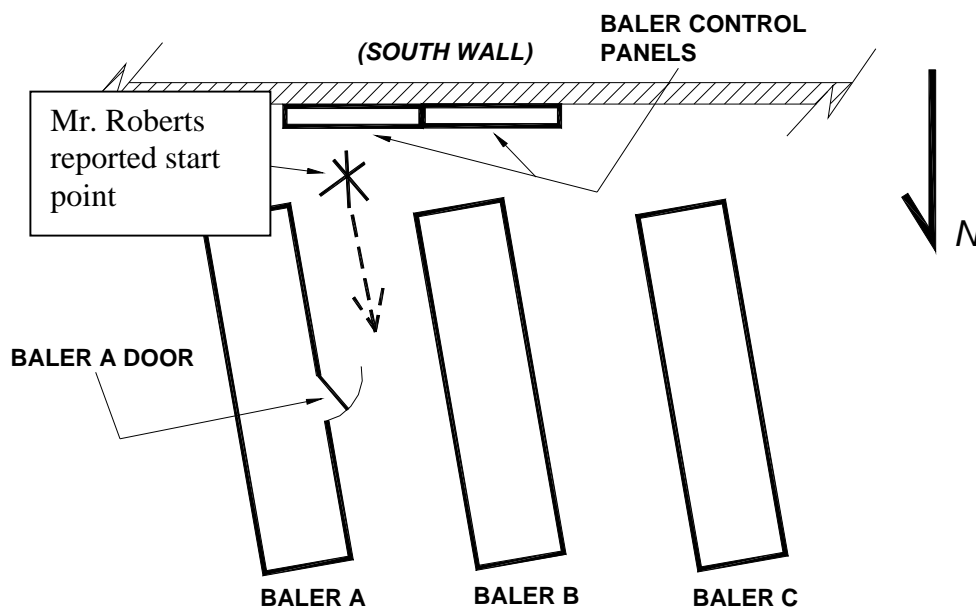
Figure 2 - Mr. Roberts's Reported Walking Path Prior to Injury Event

Per the account of the injured worker, Mr. Jimmy Roberts, he sustained his injury when he was walking in a northerly direction in the aisle way between Balers A and B. His reported path that started at the Baler Control Panels is shown below in *Figure 2*.

Mr. Roberts's reported medical injuries were not consistent with his statements of his activities prior to the injury event. Mr. Roberts stated that he was walking along the dotted path shown in *Figure 2* when the Baler A door unexpectedly opened causing him injury.

Medical authorities noted that Mr. Roberts sustained injury on the left side of his face. The bottom edge of the Baler A access door was 60 ½ inches from the floor, therefore it is consistent with the reported accounts that the door might have come into contact with only his face (i.e., the door was above the level of his chest).

*But, the left side facial injuries are consistent with Mr. Roberts facing or standing at a slight oblique angle to the access door and not simply walking beside the access door, which would have been positioned to the right of his path (reference **Figure 2**).*
