# Residential Investigation #1

Re:            *Insured:*                    Beverly McCormick  
                  *Inspection Location:*    Bloomfield, Indiana 47424

*Claim No.:*                    <omitted>  
                  *Date of Loss:*                February 2006  
                  *IC2 Project No.:*            <omitted>

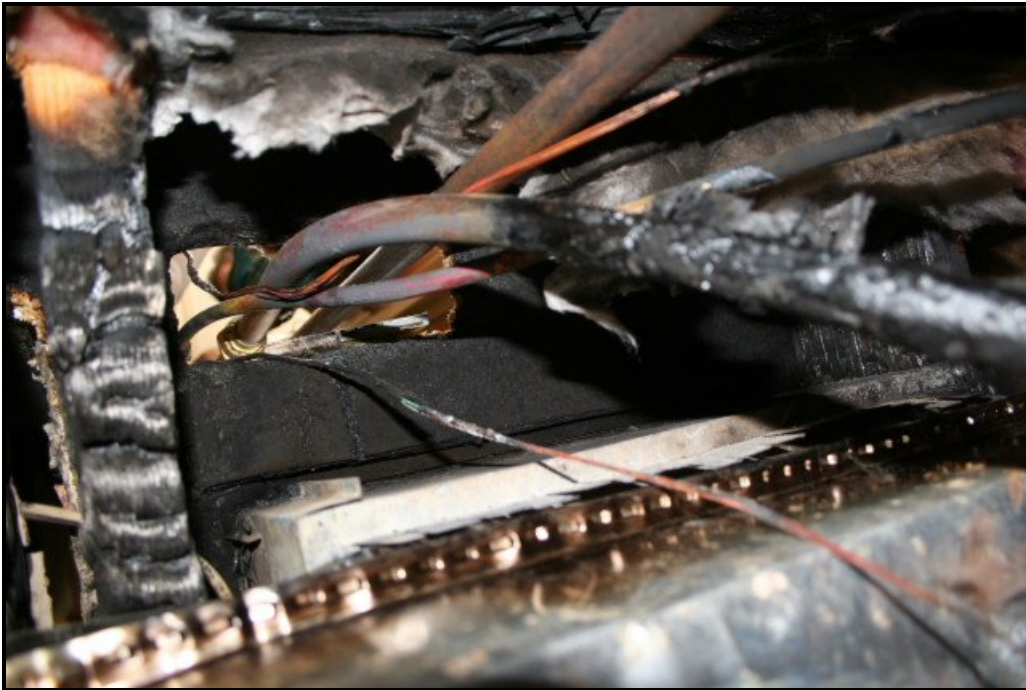
Inspection *below* the furnace, however, revealed substantial charring of the floor joists and plastic materials situated under the furnace as shown in *Figure 1*, which was recorded while looking from the crawlspace up at the sub floor beneath the furnace.

**Figure 1 - View Looking Up at Sub Floor below Furnace**

As shown in *Figure 1*, the floor joists around the furnace were charred. The electrical insulation on the conductors that spanned the region was completely consumed but there were no indications of conductor-to-conductor or conductor-to-ground shorting on any of the conductors. Nearly all plastic materials in the region below the furnace, including the fiberglass insulation binder and covering that surrounded the ducts was extensively charred or consumed.

Inspection of the structural materials beneath the furnace revealed that all wood materials surrounding the screws and nails that spanned between the sheet metal floor pan of the furnace and the wood joists (reference *Figure 1*) had been consumed. Inspection of all of the conductors that traversed the fire and heat affected region beneath the furnace revealed no indications of conductor-to-conductor or conductor-to-ground shorting of the same.

The errant ground current flowed through the structure and traveled through the furnace floor pan attachment screws. The current then utilized the steel natural gas supply pipe to flow to earth. The path was sufficiently high impedance to avoid protective action by the premises over current circuit breaker. *The current flow through the structure caused sufficient resistive heating to serve as ignition source for the fire beneath the furnace.*

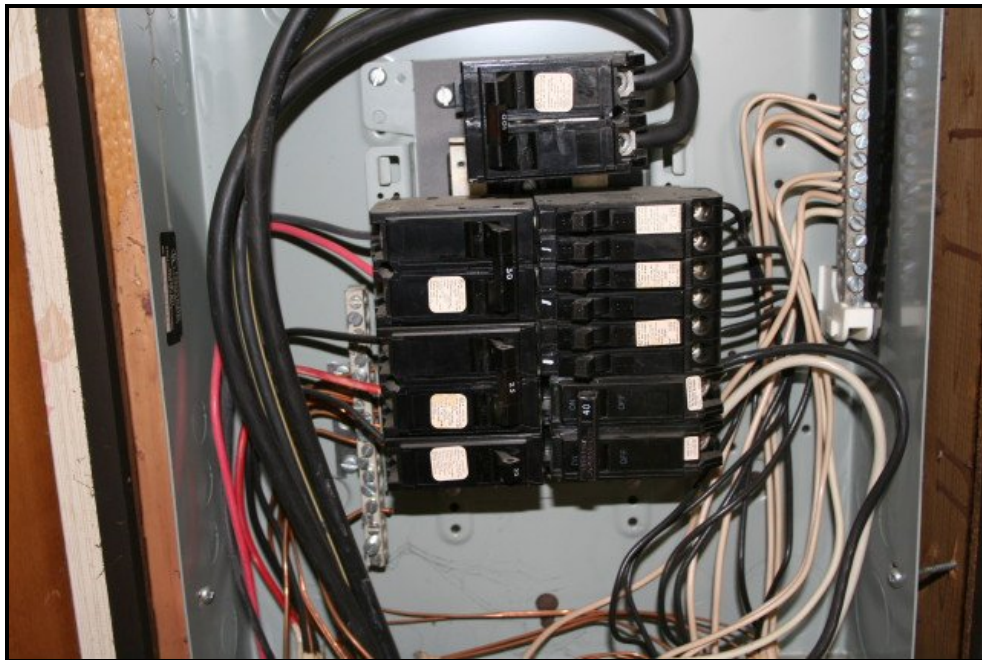
Inspection within the residence revealed that the residence was improperly connected to the electrical service. The conductors of the three wire service (i.e., L1, L2, and neutral) were properly connected to their respective connections on the main disconnect breaker and the isolated neutral bus bar. But, the service installer did not connect the isolated ground bus to a grounding electrode via a grounding electrode conductor. Consequently, the residence had a floating ground system that was not connected to earth.

**Figure 2 – View of Residential Service Connection with No Grounding Electrode Conductor**

*The fire was caused by improper connection of electrical service to the manufactured home by an unknown party(s). Contrary to the requirements of the National Electrical Code, the service installer did not install a grounding electrode or conductor to the manufactured home isolated ground bus.*
