# Residential Investigation #3

Re:	<i>Insured:</i>	Gas Company #1
	<i>Loss Location:</i>	Ohio
	<i>Claim No.:</i>	<omitted>
	<i>Date of Loss:</i>	October 2003
	<i>IC1 Project No.:</i>	<omitted>

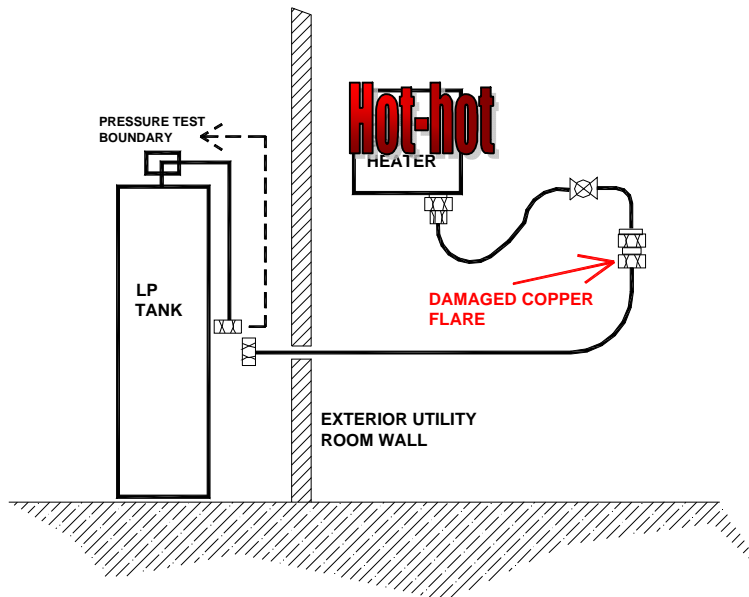
**Figure 1 - LP System Layout**

The author performed a soap bubble leak check of the Gas Company #1-supplied LP gas piping from the top of the Gas Company #1 120 gallon storage tank, through the regulator, to the 3/8 inch copper distribution pipe that remained connected to the regulator. As shown in **Figure 1**, the distribution pipe had been previously disconnected external to the residence, presumably by the claimant's son.

The author connected stopcocks with a precision manometer gauge to the end of the Gas Company #1 3/8 inch copper tube at the boundary shown in **Figure 1** (*Photograph 8*). The author opened the tank isolation valve to permit pressurization of the tube with LP

No anomalous conditions were discovered with the Hot-hot heater. The author did discover one copper flare, positioned as shown in **Figure 1**, to be severely deformed and the sealing surface was heavily scored and distorted (*Photograph 13*). In addition, Teflon sealing tape had inappropriately been applied to the flared tubing joint.

The author, however, discovered two anomalies in the inspected portion of the claimant's LP gas distribution system, and both items were situated within the residence. One of the copper flares, which was situated at the position shown in **Figure 1**, was heavily scored and distorted. Such indications are created when a flare nut connection is tightened when the copper tube flare is not squarely aligned with the associated mating flare. In addition, an unknown party(s) had improperly used Teflon sealing tape in the subject flare connection.
