Restaurant Investigation #2

June 2006

Re:	<i>Insured:</i>	Restaurant #1
	<i>Loss Location:</i>	Kentucky
	<i>Claim No.:</i>	N/A
	<i>Date of Loss:</i>	January 2004
	<i>ICI Project No.:</i>	<omitted>

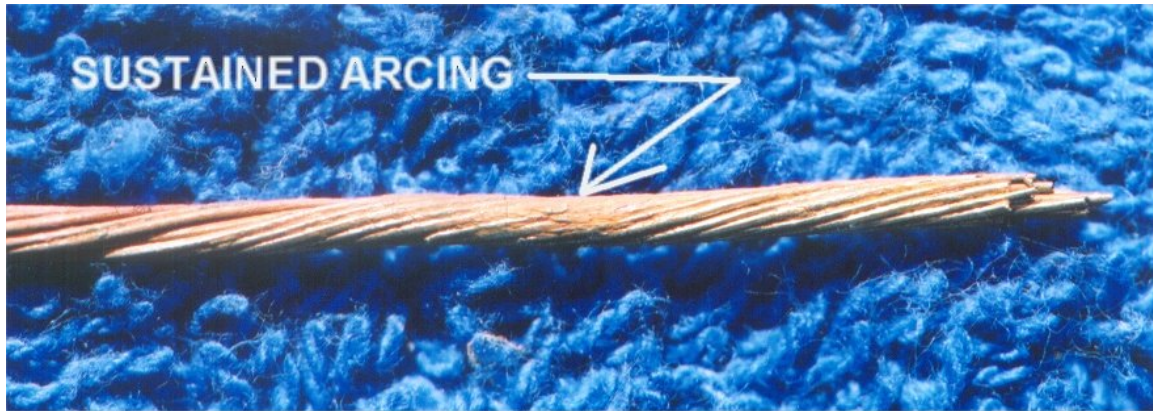
Figure 1 - Sustained Arcing Indications on GTO-15 Neon Secondary Conductor

GTO-15 neon conductors had a fused and melted section, presumably from arcing with a grounded object.

Figure 1, which was created from *Photograph 24*, shows an annotated view of the sustained arcing on the neon secondary conductor. The damage consisted of fused strands and metal transfer to another conductor. The author discovered the particular section in the debris behind the checkout counter.
